Continental Remediation LLC

Completed Project-Home Heating Oil Remediation - Ringwood, New Jersey

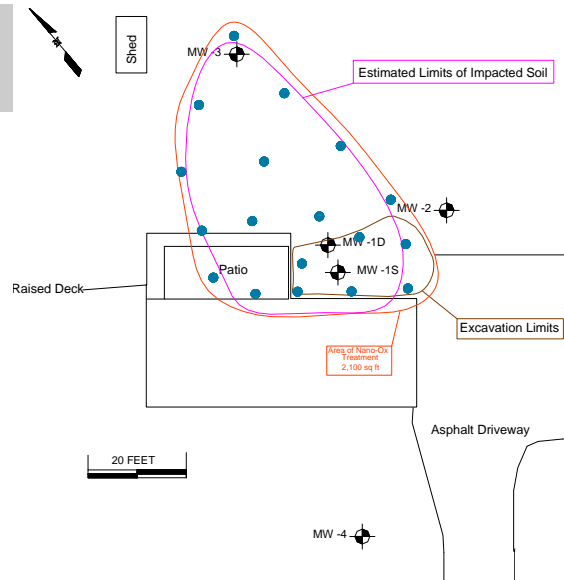
Contamination extended to 19' below surface as well as under deck and residence. Groundwater was approximately 6' below surface. Down gradient MW-3 displayed Tetrachloroethene above standards. This area was included in the treatment and removed all traces of the chlorinated compounds. Injections were performed on 6/27/07 and the first groundwater samples taken on 7/31/07. Only one compound was marginally over the NJDEP standards. All were below by 9/27/07.
